## THE SCREEN

2<sup>nd</sup> December 2011

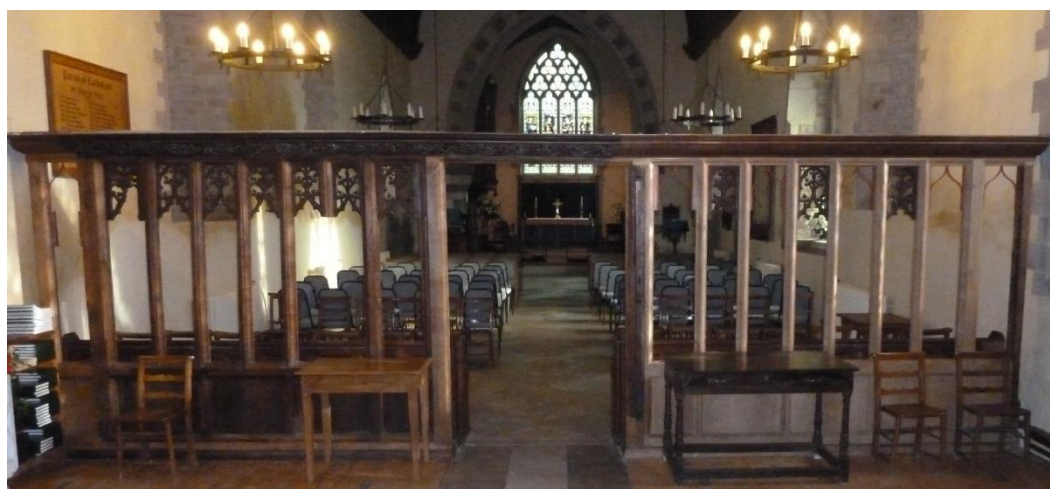
Its final move, to the position illustrated at the start of this Paper, took place in 1999<sup>6</sup>. It is positioned north-south across the nave, not far east of the entrance to the church. Only the north portion of the present screen is from the early screen, the south portion having been made by local craftsmen in imitation of the old in 1999.
